**Vulcan**

# Elektronikus vízkőmentesítő rendszer Hűtőtorony alkalmazások

## Vulcan – a vegyszermentes megoldás

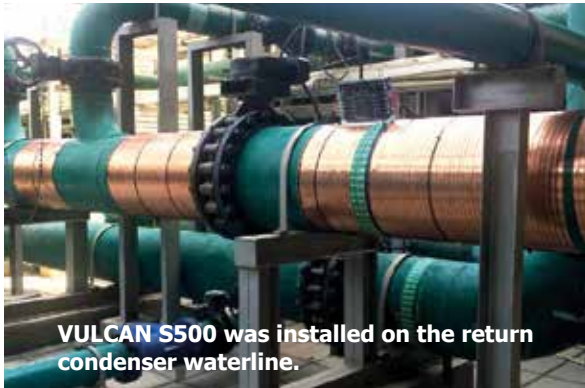
VULCAN S500 was installed on the return condenser waterline.

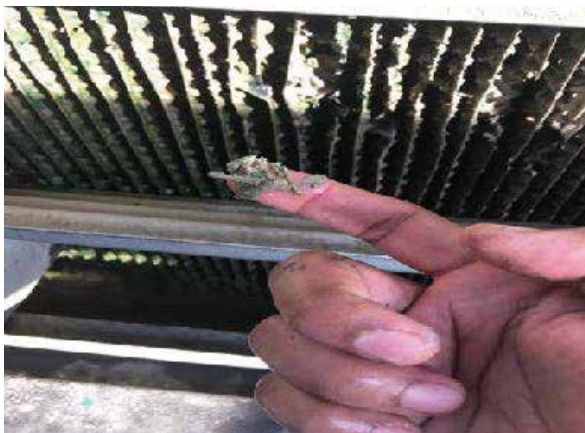
With Vulcan, scale becomes loose.

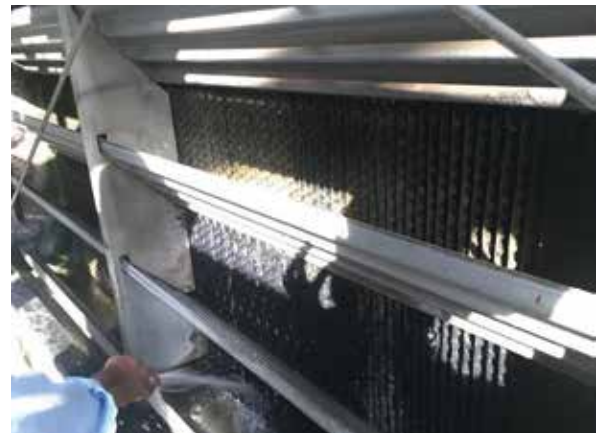
Scale and algae can be removed easily by a water gun.

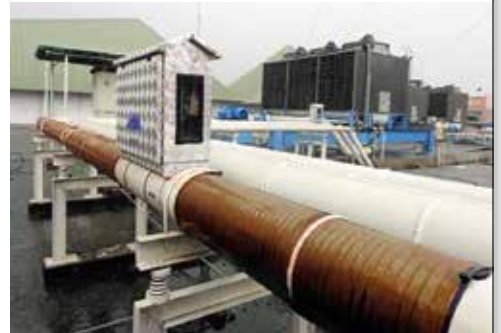
Vulcan S500 was located inside aluminum box and installed on a cooling tower main pipe.

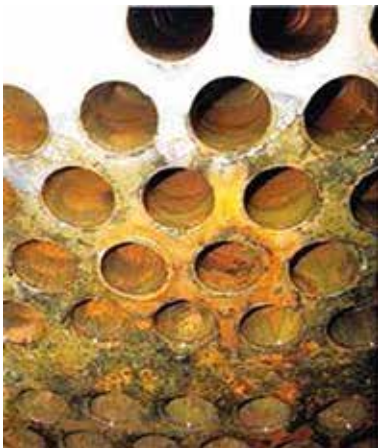
**First Inspection: March 4, 2014.**

The heat exchanger tube plates were removed to reveal the inside surface of the copper tubes. Since these tubes had recently been manually cleaned, virtually no scale was present, as is on this photo.

**The photographs show that the refrigeration condenser tubes, from the beginning to the end of the trial period, were "as clean as new".**

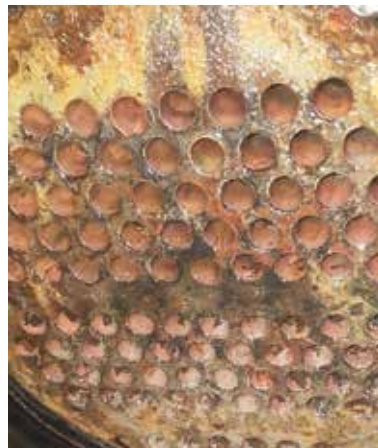
**Last inspection: February 12, 2018 at the end of the 4-year trial**

The inside surfaces of the copper tubes show zero additional scale formation after 4 years in the test period.

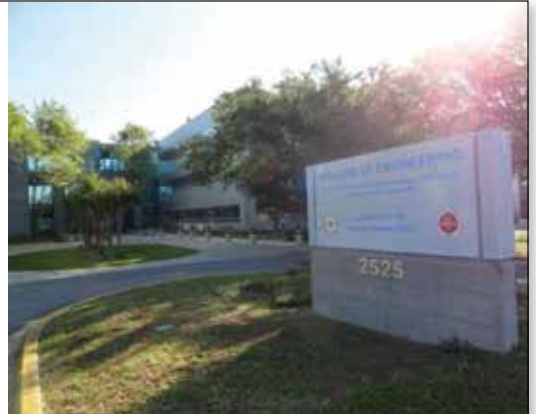
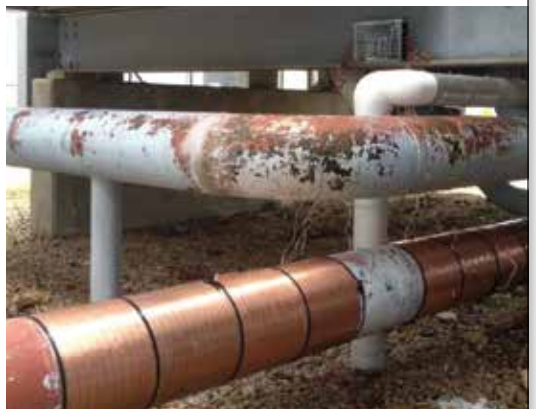
Vulcan S250 installed on a 10 inch diameter line that feeds twin cooling towers (CT-1 and CT-2)

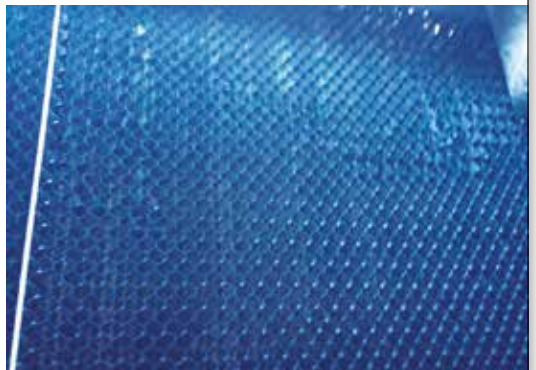
The inside of CT-1, after **3 weeks** with Vulcan. It illustrates clean flutes that are in constant contact with Vulcan-treated water and a few dry (untreated) areas that still have some remaining green biofilm.

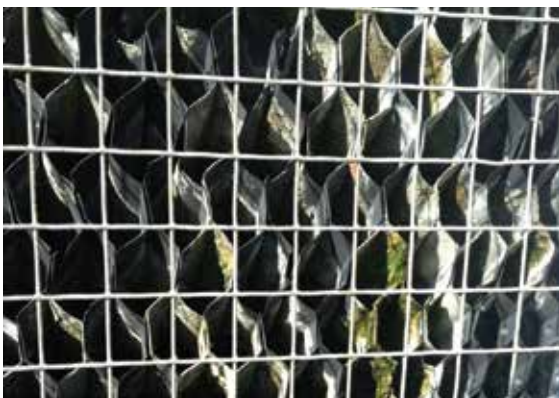
The photo above was taken of CT-1 about **3 weeks** after the Vulcan was installed.

**After 3 weeks**, the green biofilm had been further reduced and the scale deposits had begun to separate from the flutes in coin-sized flakes.

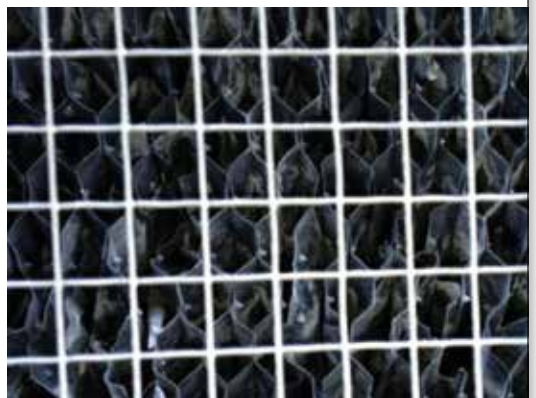
The photo above was taken of CT-1 about **6 weeks** after the Vulcan was installed.

**After 1 month**, the green biofilm had almost completely disappeared from the surfaces in contact with the Vulcan-treated water. The flakes of scale previously observed had fallen off in most places. The cooling tower flute surface area covered with scale deposits had been decreased by **over 60%**.

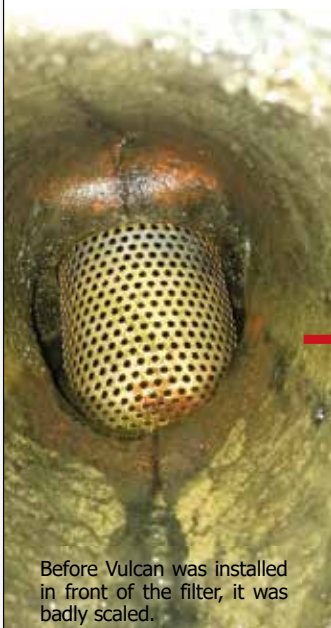
Before Vulcan was installed in front of the filter, it was badly scaled.

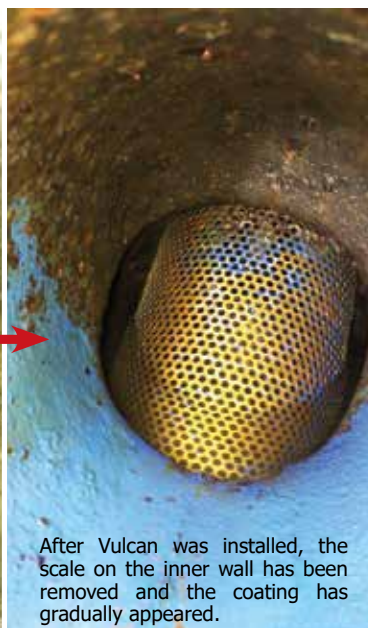
After Vulcan was installed, the scale on the inner wall has been removed and the coating has gradually appeared.

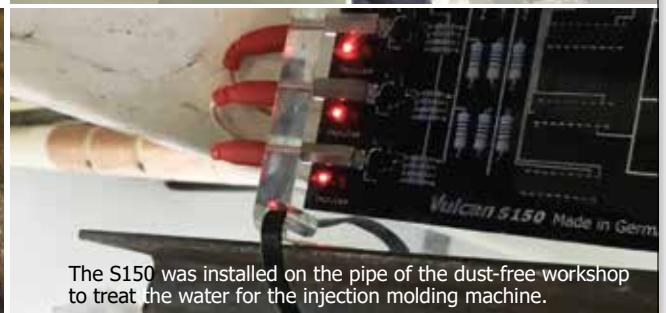
The S150 was installed on the pipe of the dust-free workshop to treat the water for the injection molding machine.

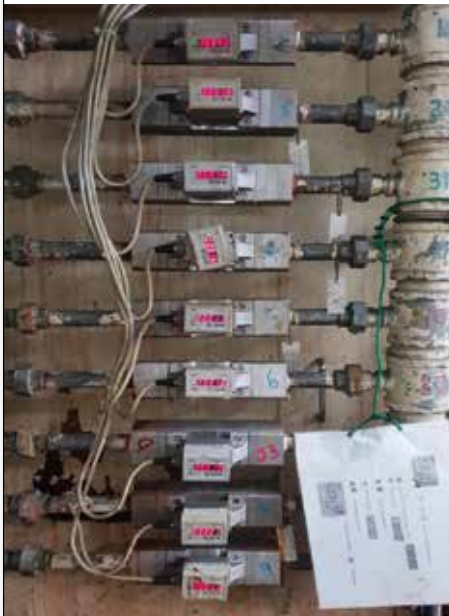
There are 9 secondary small pipes with water meters. These meters were installed to make sure a stable flow rate. If the flow rate goes down, it would cause a problem of the induction hardening machine. Therefore, the pipes had to be cleaned manually every 2-3 months.

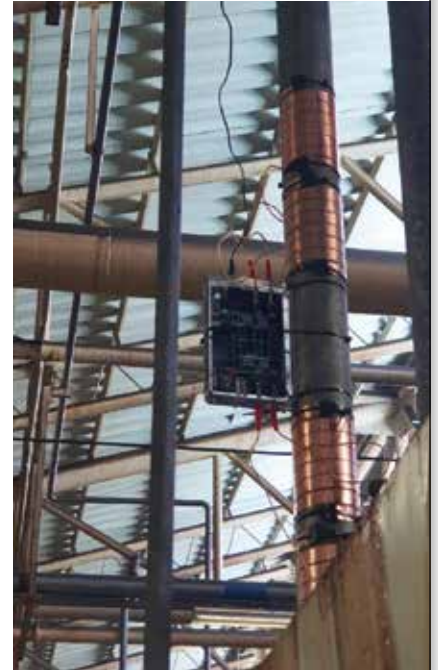
Vulcan S25 was installed around 50 meter before the induction hardening machine.

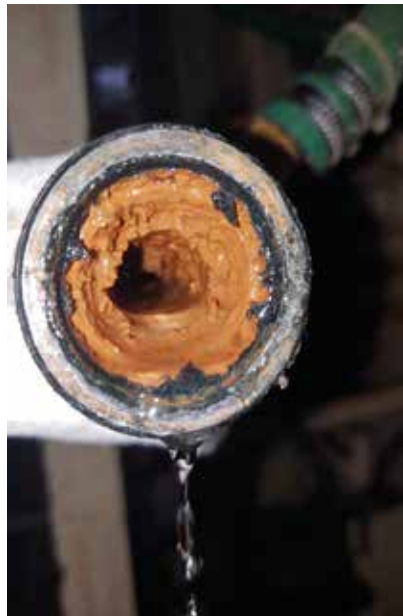
**First inspection:** May 21, 2018.

Inside of a secondary small pipe, before Vulcan S25 was installed.

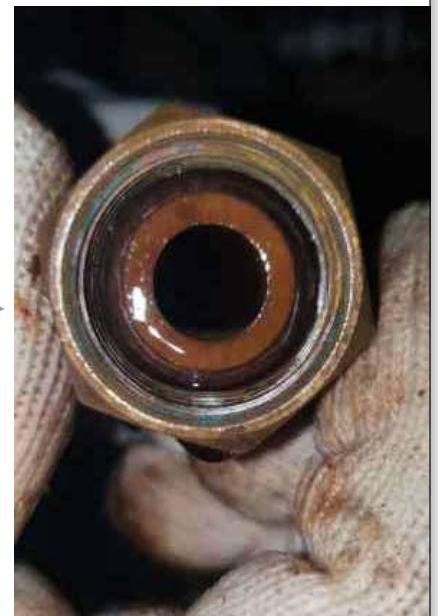
**Last inspection:** November 21, 2018.

After 6 months with Vulcan treatment: the pipe is free of scale.

2. After Vulcan S25 had been installed for 6 months, the secondary pipes were opened: scale that had been left in piping had disappeared and all 9 secondary pipes had become clean (see photo).

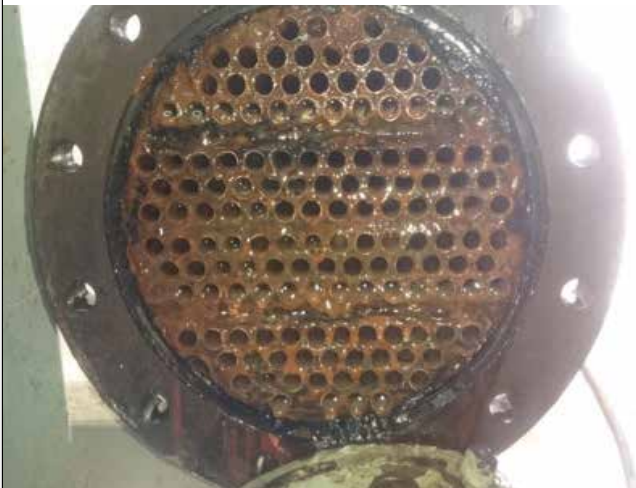
Heat exchanger before Vulcan installation

- scale deposits in oil heat exchanger
- oil temperature >50°C: vey high
- to clean every month
- heat exchanger has corrosion
- scale deposits clog the pipe

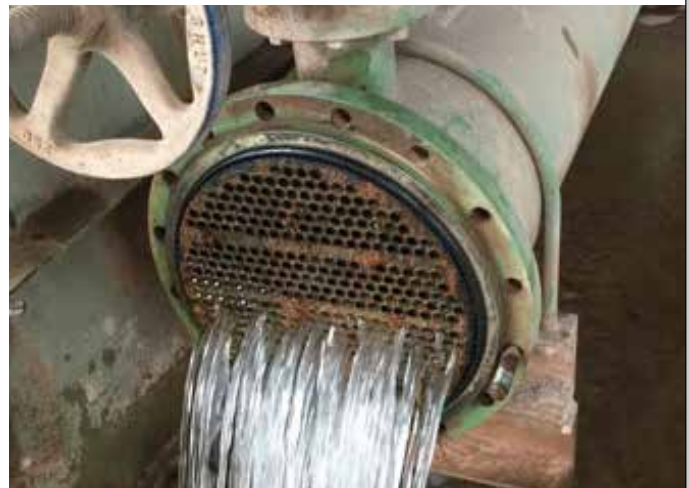
Heat exchanger after 2 months Vulcan installation

- oil heat exchanger is clean
- temperature is stable at 37°C – 40°C
- no need to stop machines to clean anymore
- save 7% energy consumption at grinders

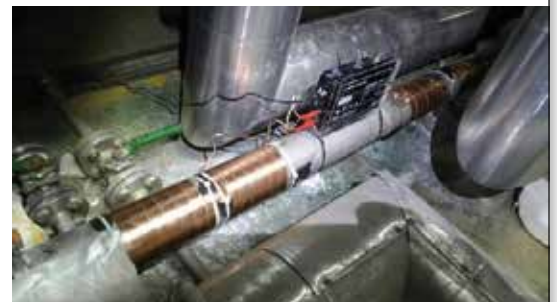
Vulcan S25 installed at Toray Industries

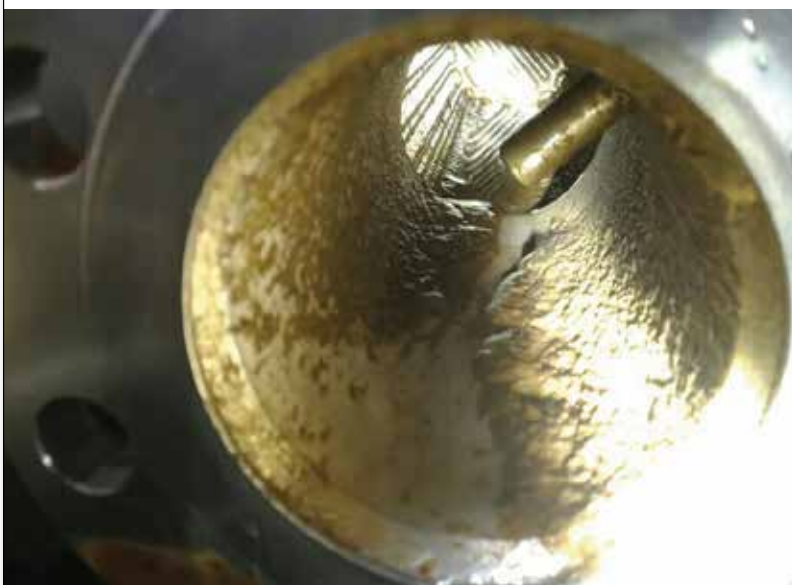
Before – without Vulcan

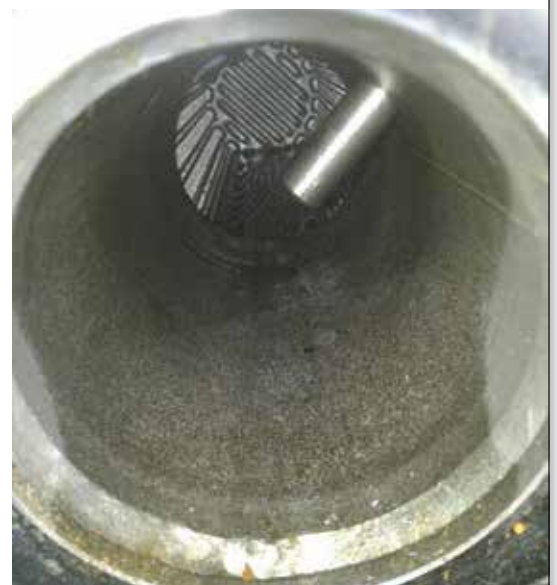
After 3 months – with Vulcan treatment. Up to now the installed pipeline needed no cleaning.

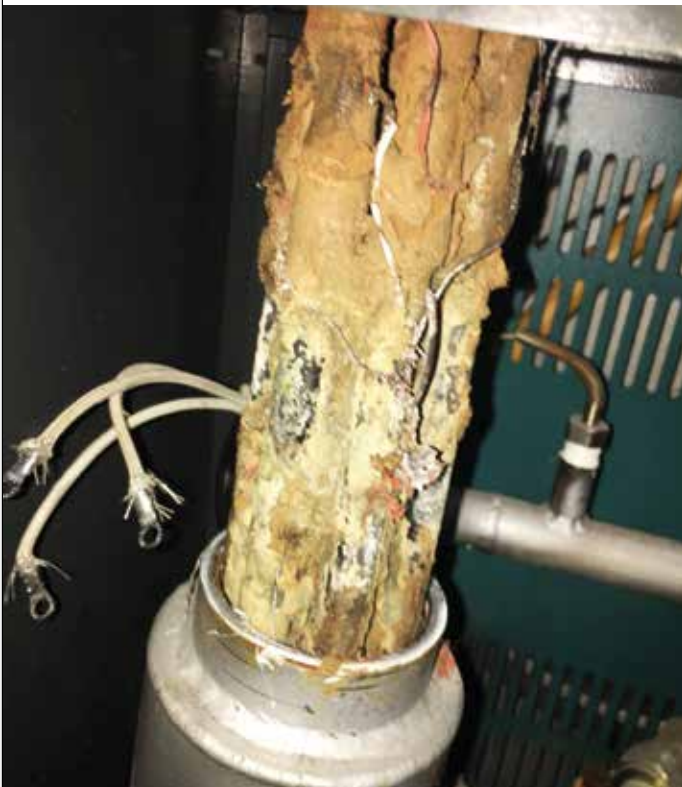
Untreated heat exchanger for 3 years.

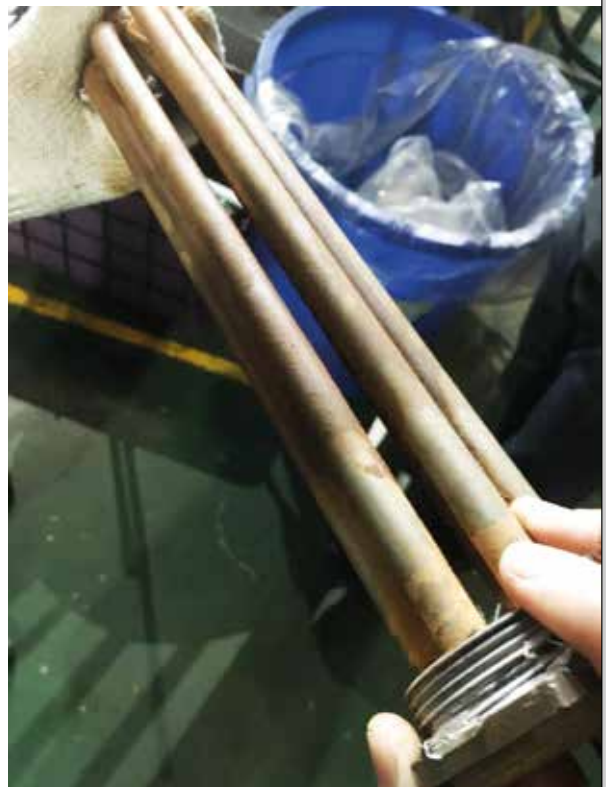
After installing Vulcan for 1.5 years, the scale is gone without extra cleaning.

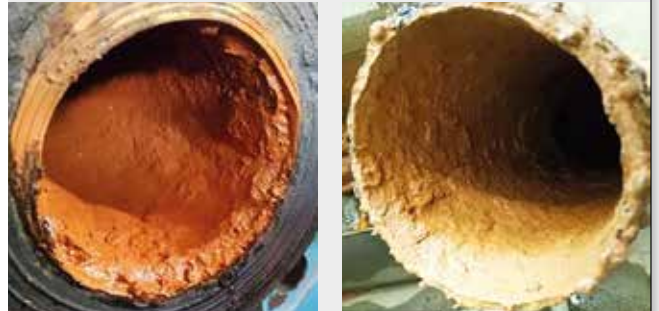
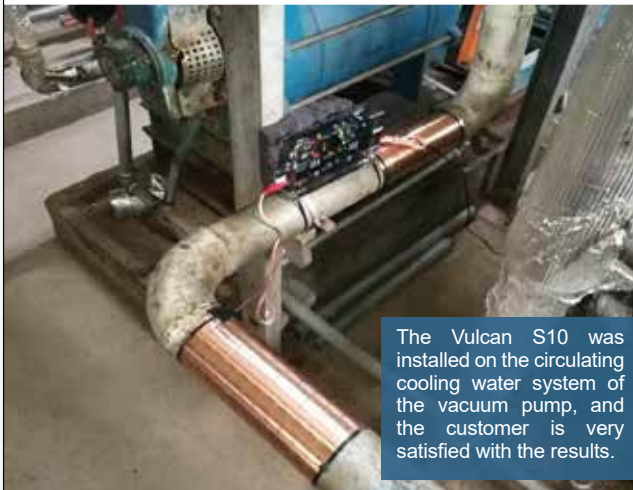
The pipe had been used for 15 years and had a very thick hard scale layer inside. The pipe was not cleaned before Vulcan S10 was installed. The following two photos are the observation points selected before Vulcan installation.

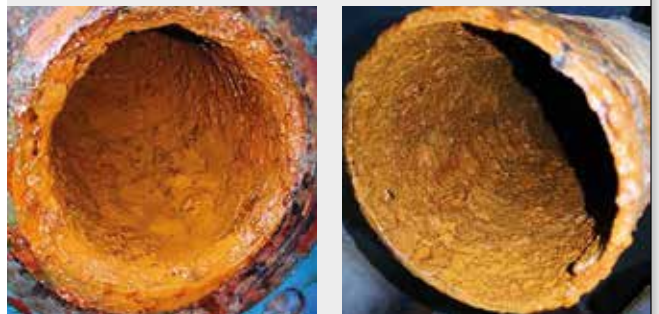
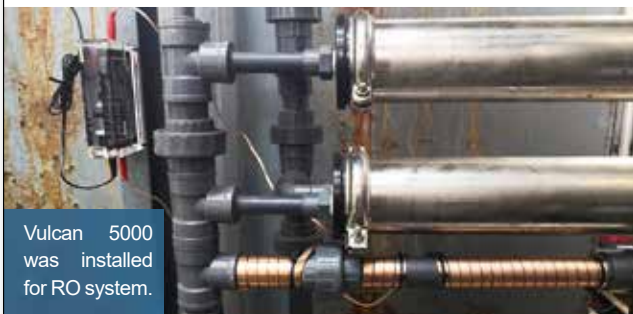
The scales inside the pipe have been gradually reduced, and they do not fall off in blocks, which will not affect the operation of pumps and other equipment. Because of the good results, the customer decides to apply Vulcan in several other cooling systems.

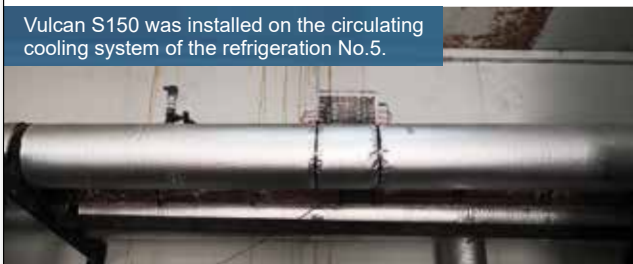
Vulcan S150 was installed on the circulating cooling system of the refrigeration No.5.

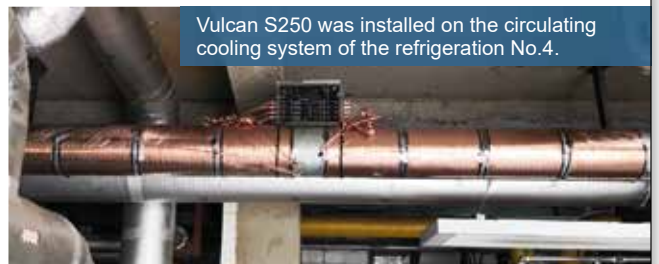
Vulcan S250 was installed on the circulating cooling system of the refrigeration No.4.

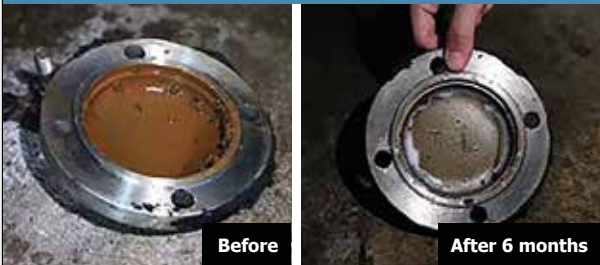
Cooling tower valve: large amount of sludge and scale have been gradually reduced.

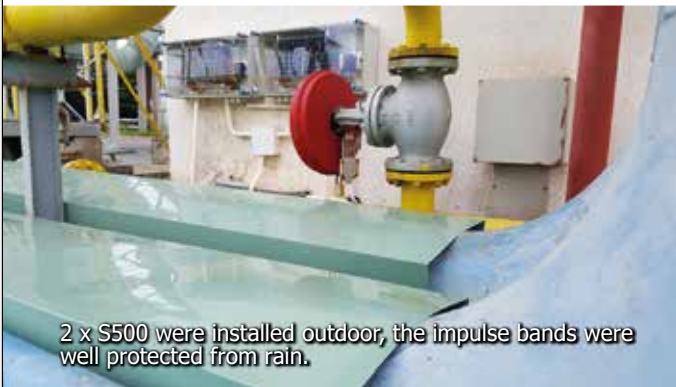
2 x S500 were installed outdoor, the impulse bands were well protected from rain.

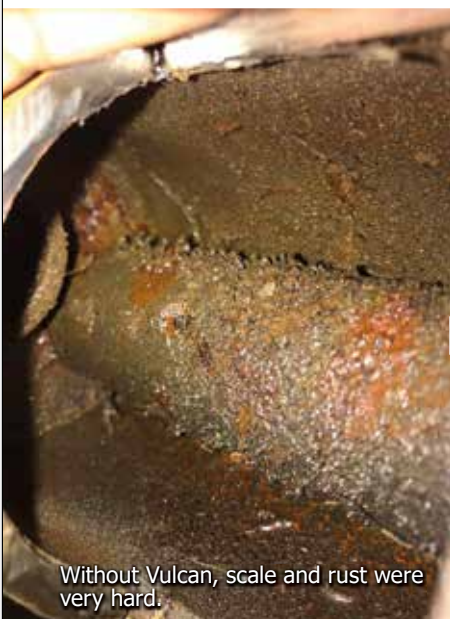
Without Vulcan, scale and rust were very hard.

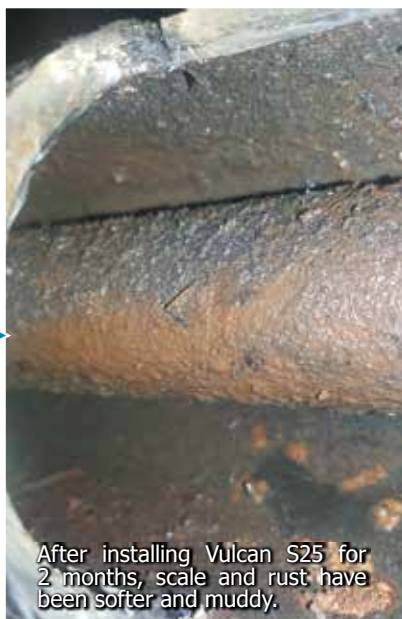
After installing Vulcan S25 for 2 months, scale and rust have been softer and muddy.

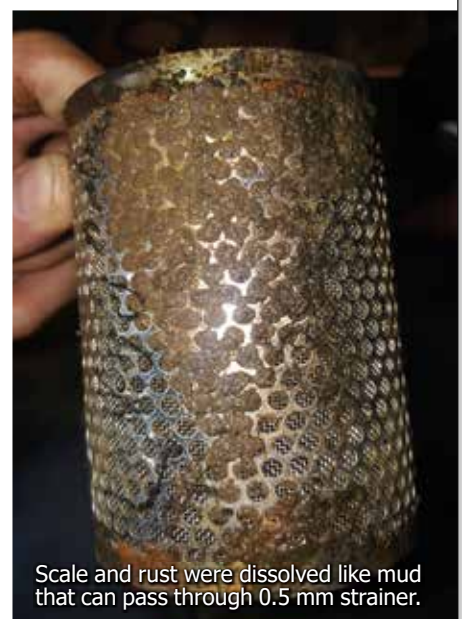
Scale and rust were dissolved like mud that can pass through 0.5 mm strainer.

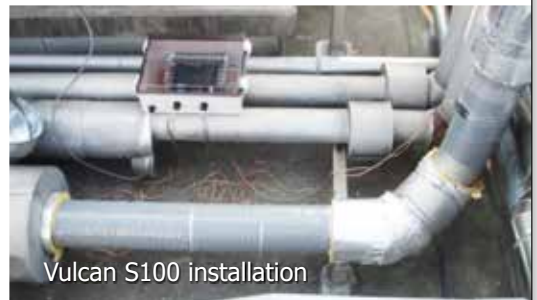
Vulcan S100 installation

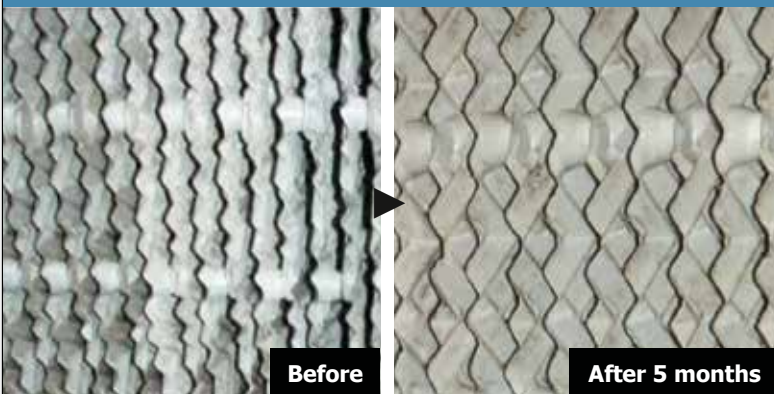
#### The inside of the cooling tower fill

Scale has been reduced.

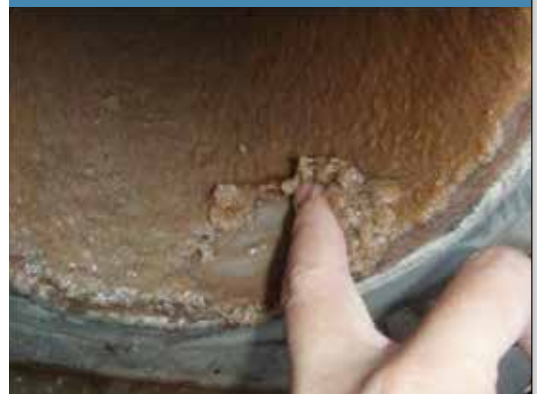
#### Circulation pipe

Scale becomes soft and can be easily removed with a finger.
