The Electronic Anti-Scale System For Cooling Tower Applications

Vulcan Effects on Cooling Towers

Vulcan test report on a cooling tower

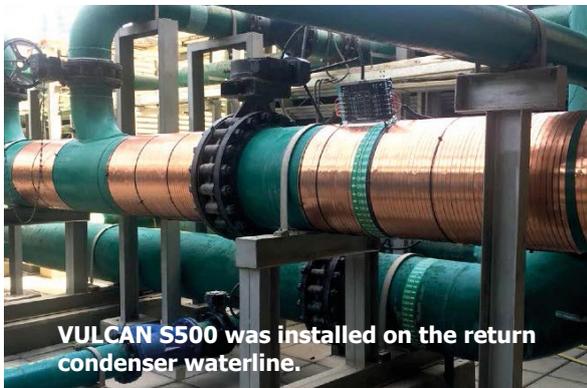
VULCAN S500 was installed on the return condenser waterline.

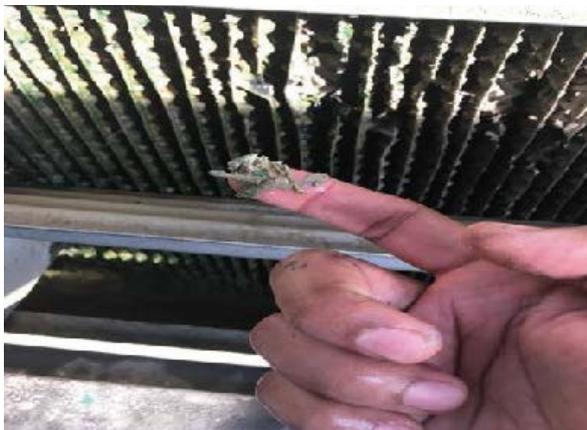
With Vulcan, scale becomes loose.

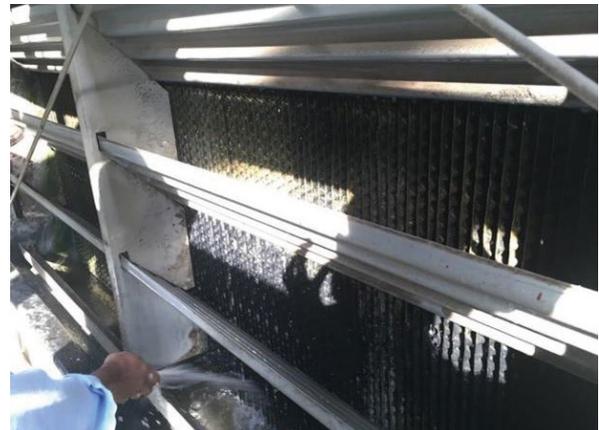
Scale and algae can be removed easily by a water gun.

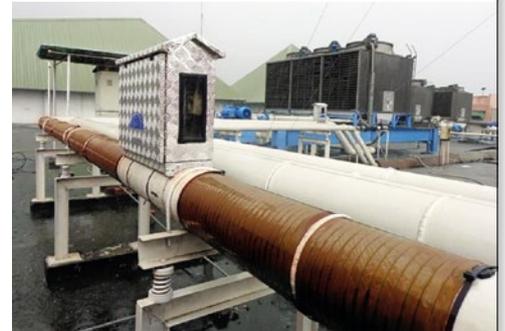
Vulcan S500 was located inside aluminum box and installed on a cooling tower main pipe.

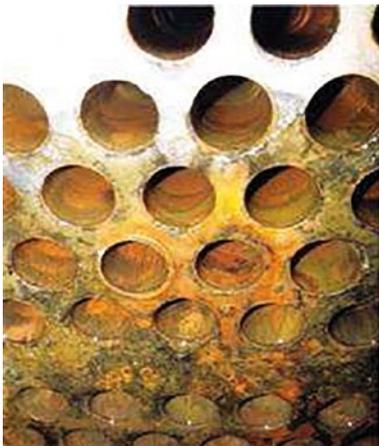
First Inspection: March 4, 2014.

The heat exchanger tube plates were removed to reveal the inside surface of the copper tubes. Since these tubes had recently been manually cleaned, virtually no scale was present, as is on this photo.

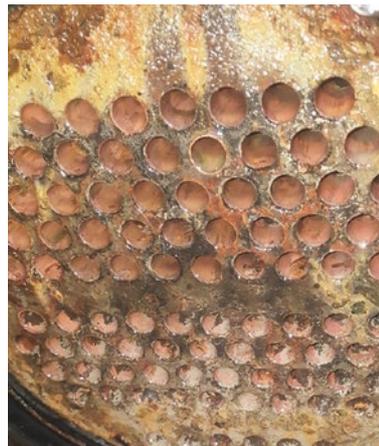
Last inspection: February 12, 2018 at the end of the 4-year trial

The inside surfaces of the copper tubes show zero additional scale formation after 4 years in the test period.

The photographs show that the refrigeration condenser tubes, from the beginning to the end of the trial period, were "as clean as new".

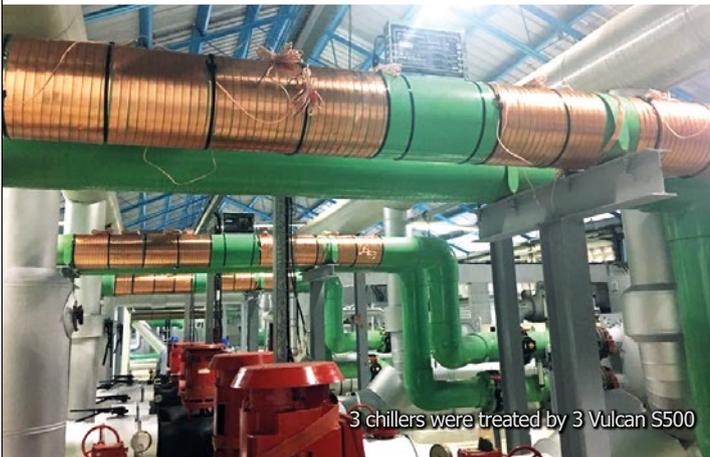
3 chillers were treated by 3 Vulcan S500

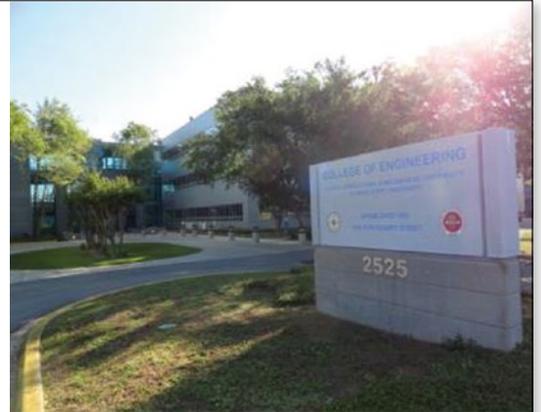
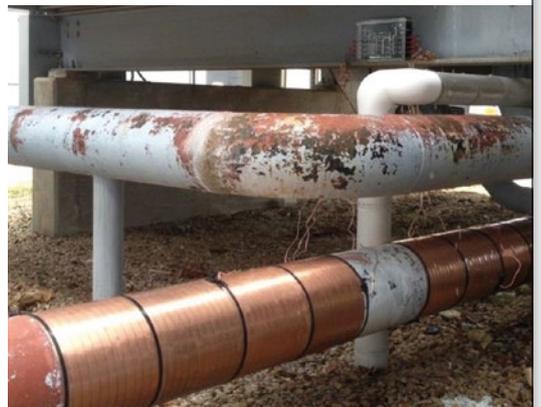
Vulcan S250 installed on a 10 inch diameter line that feeds twin cooling towers (CT-1 and CT-2)

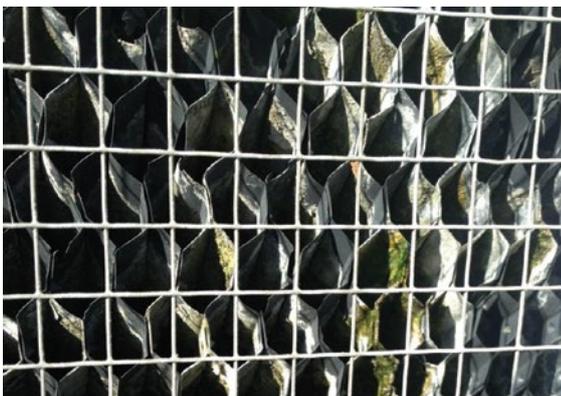
The photo above was taken of CT-1 about **3 weeks** after the Vulcan was installed.

After 3 weeks, the green biofilm had been further reduced and the scale deposits had begun to separate from the flutes in coin-sized flakes.

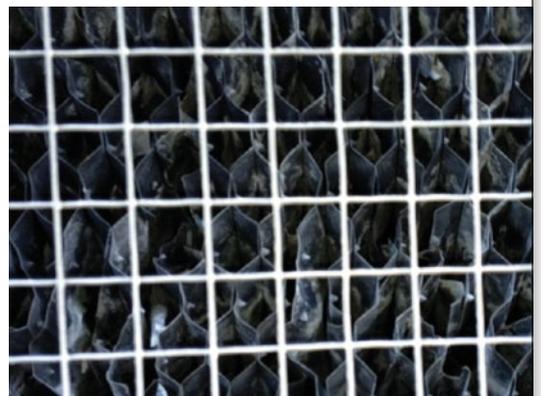
The photo above was taken of CT-1 about **6 weeks** after the Vulcan was installed.

After 1 month, the green biofilm had almost completely disappeared from the surfaces in contact with the Vulcan-treated water. The flakes of scale previously observed had fallen off in most places. The cooling tower flute surface area covered with scale deposits had been decreased by **over 60%**.

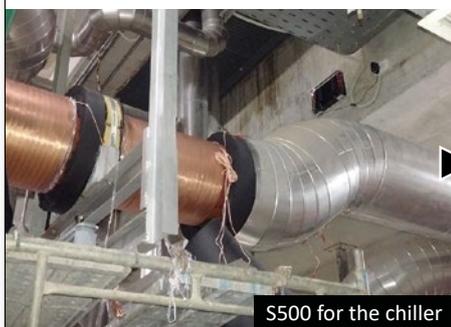
S500 for the chiller

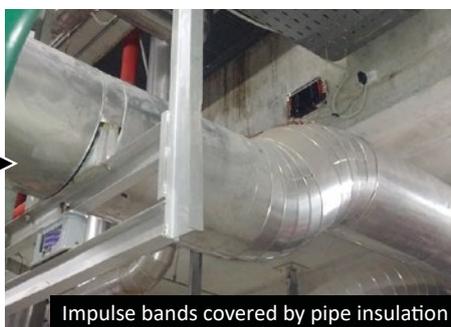
Impulse bands covered by pipe insulation

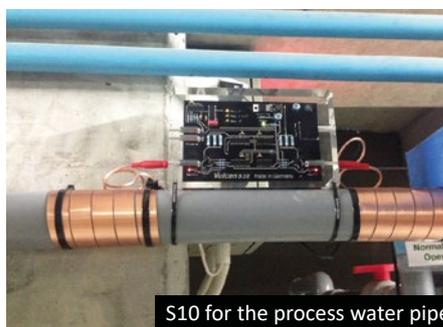
S10 for the process water pipe

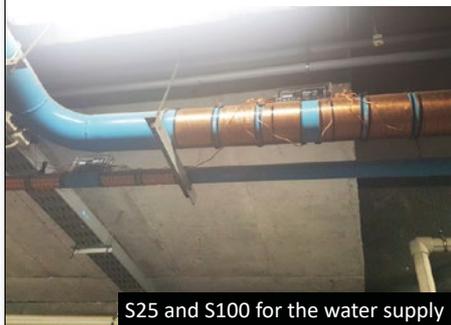
S25 and S100 for the water supply

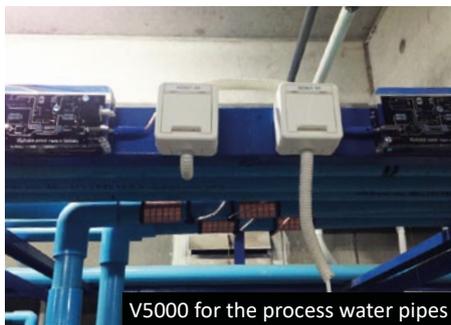
V5000 for the process water pipes

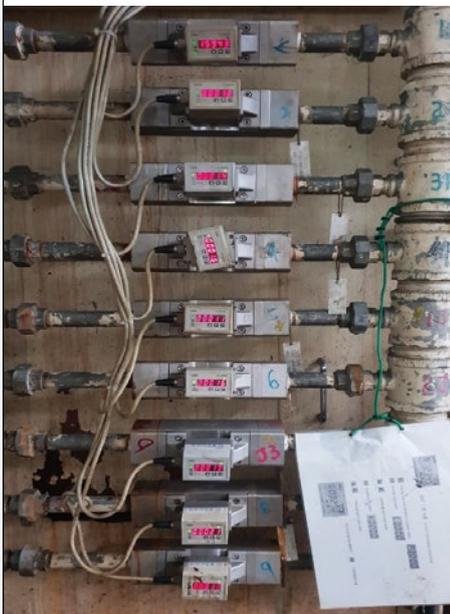
There are 9 secondary small pipes with water meters. These meters were installed to make sure a stable flow rate. If the flow rate goes down, it would cause a problem of the induction hardening machine. Therefore, the pipes had to be cleaned manually every 2-3 months.

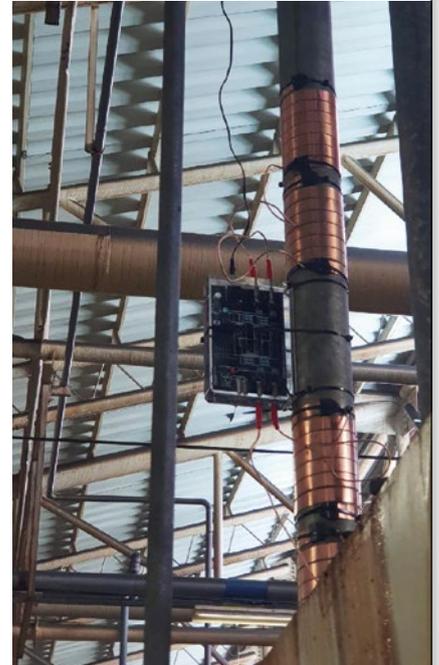
Vulcan S25 was installed around 50 meter before the induction hardening machine.

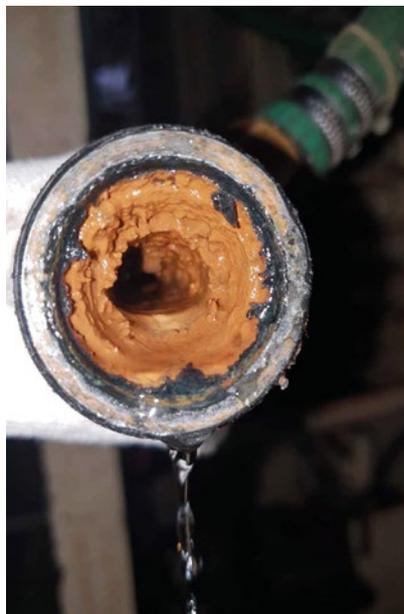
First inspection: May 21, 2018.

Inside of a secondary small pipe, before Vulcan S25 was installed.

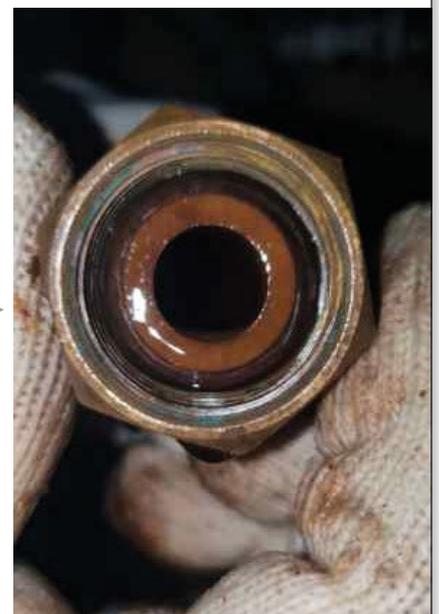
Last inspection: November 21, 2018.

After 6 months with Vulcan treatment: the pipe is free of scale.

2. After Vulcan S25 had been installed for 6 months, the secondary pipes were opened: scale that had been left in piping had disappeared and all 9 secondary pipes had become clean (see photo).

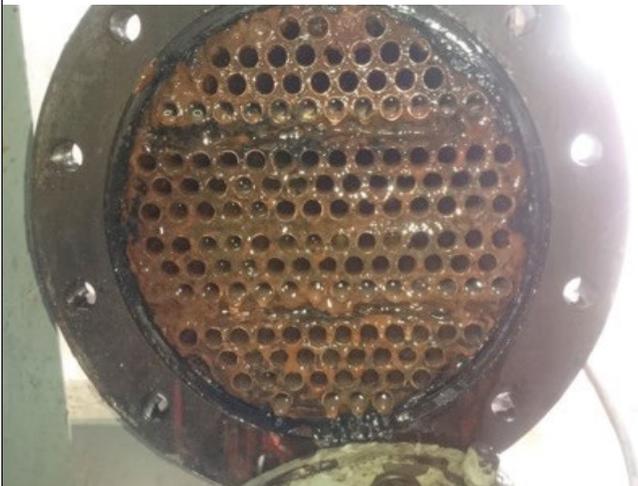
Heat exchanger before Vulcan installation

- scale deposits in oil heat exchanger
- oil temperature >50°C: very high
- to clean every month
- heat exchanger has corrosion
- scale deposits clog the pipe

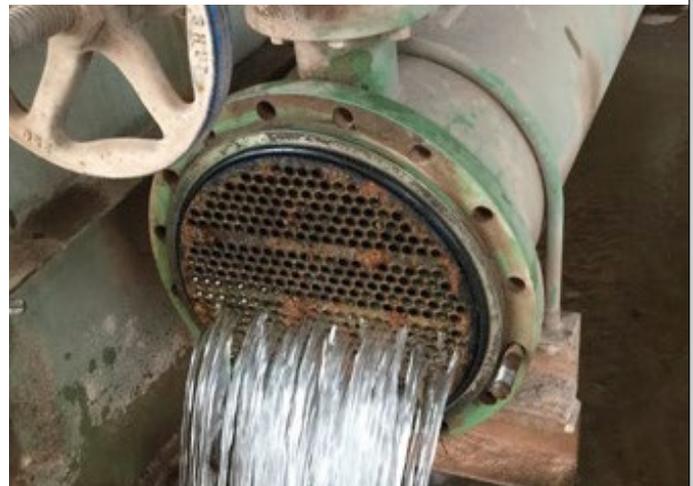
Heat exchanger after 2 months Vulcan installation

- oil heat exchanger is clean
- temperature is stable at 37°C – 40°C
- no need to stop machines to clean anymore
- save 7% energy consumption at grinders

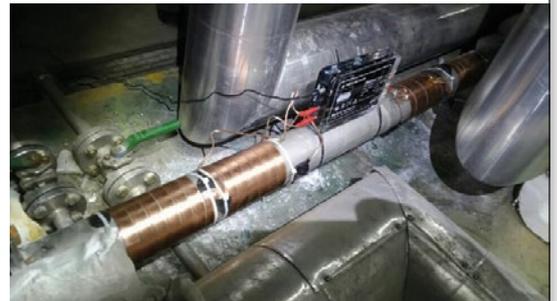
Vulcan S25 installed at Toray Industries

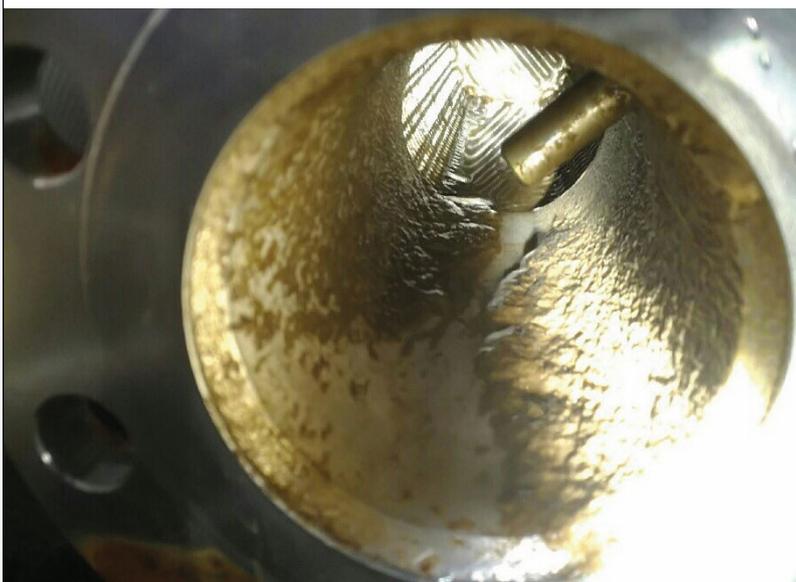
Before – without Vulcan

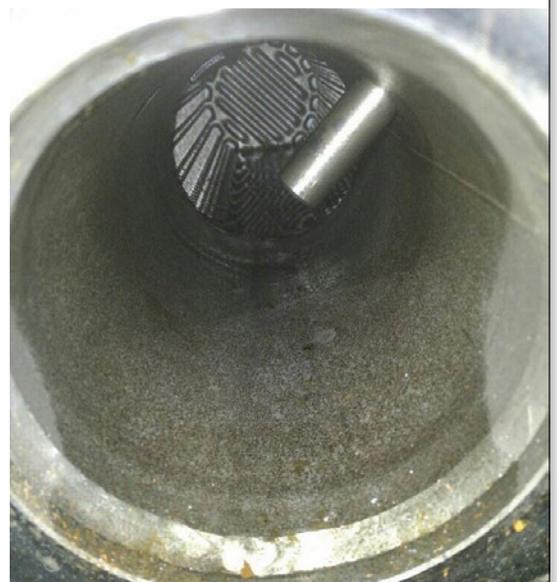
After 3 months – with Vulcan treatment.
Up to now the installed pipeline needed no cleaning.

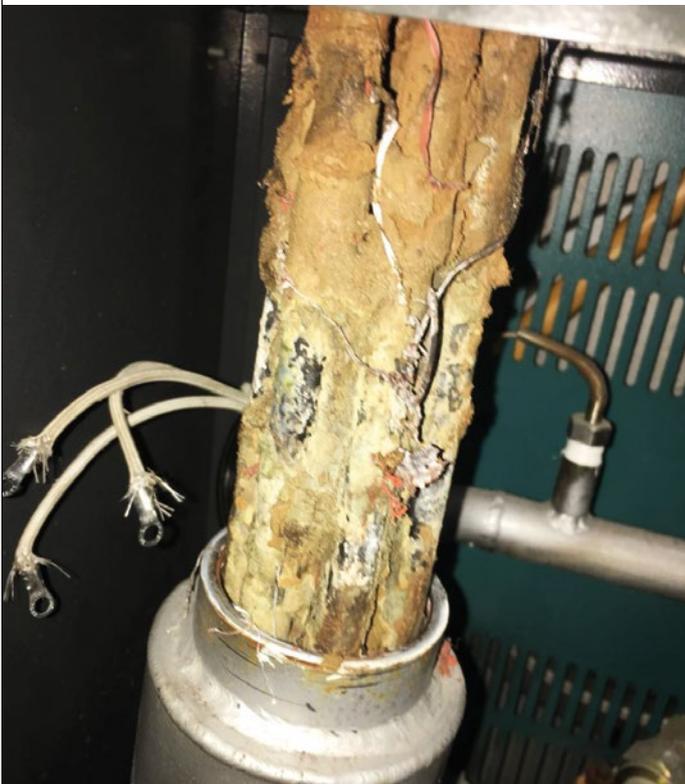
Untreated heat exchanger for 3 years.

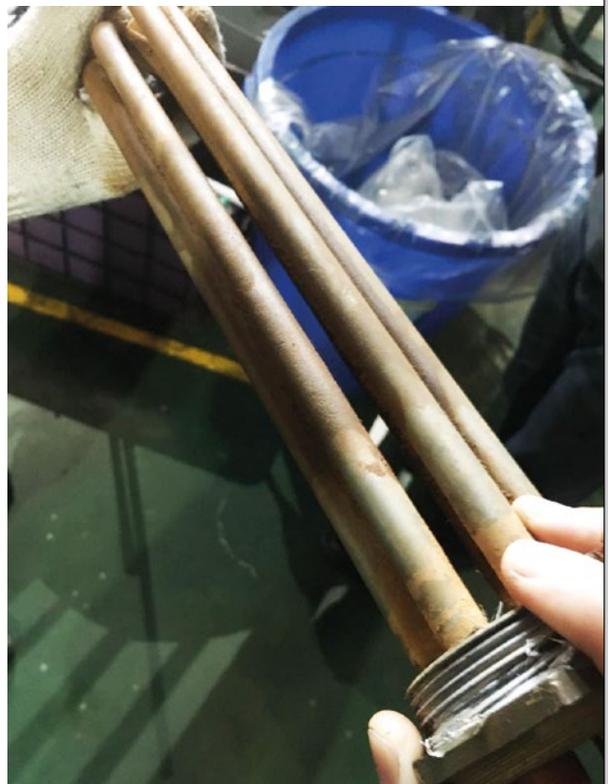
After installing Vulcan for 1.5 years, the scale is gone without extra cleaning.

One and a half years after Vulcan was installed, we opened the mold temperature controller and checked the heat exchanger.

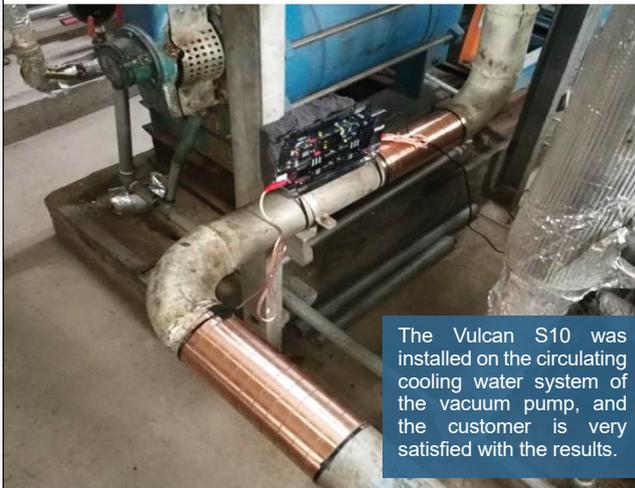
The Vulcan S10 was installed on the circulating cooling water system of the vacuum pump, and the customer is very satisfied with the results.

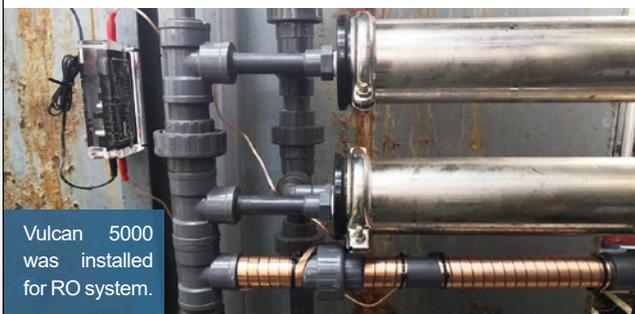
Vulcan 5000 was installed for RO system.

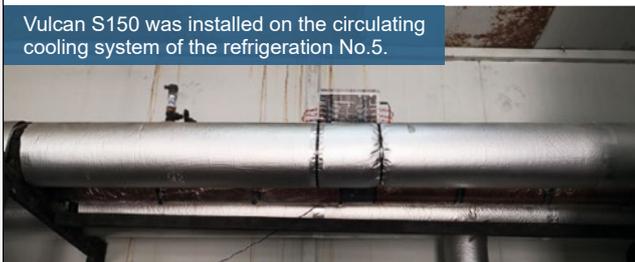
Vulcan S150 was installed on the circulating cooling system of the refrigeration No.5.

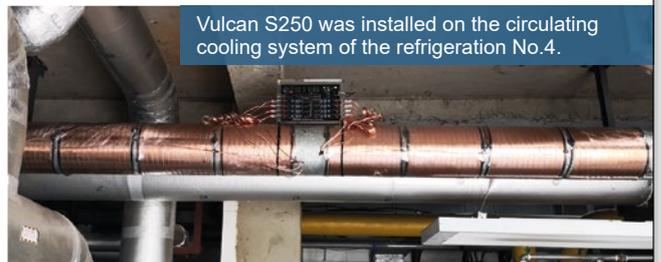
Vulcan S250 was installed on the circulating cooling system of the refrigeration No.4.

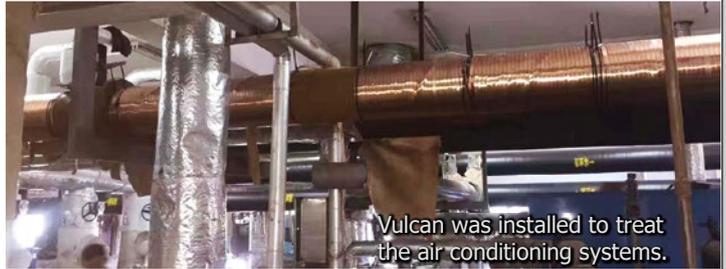
Vulcan effect in the factory — before and after

Cooling tower fins: the silica (SiO_2) which was usually accumulated in the fins has disappeared; the energy consumption of the air conditioning systems and the cleaning effort have been reduced.

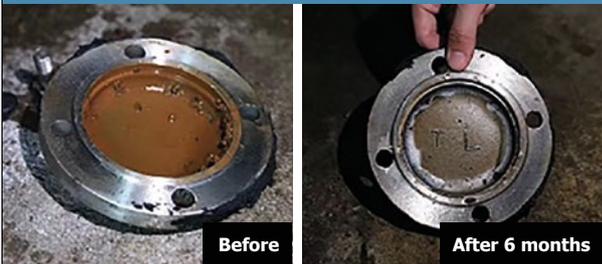
Cooling tower valve: large amount of sludge and scale have been gradually reduced.

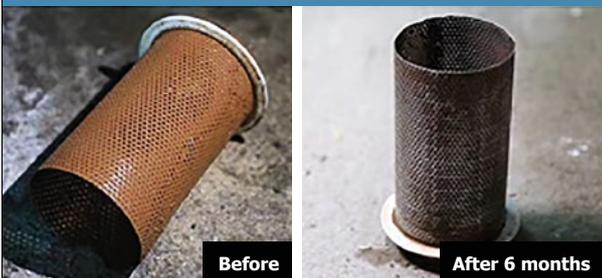
Pipe fittings in the office: they were seriously corroded, now the rust and mud on the inner wall have gradually disappeared.

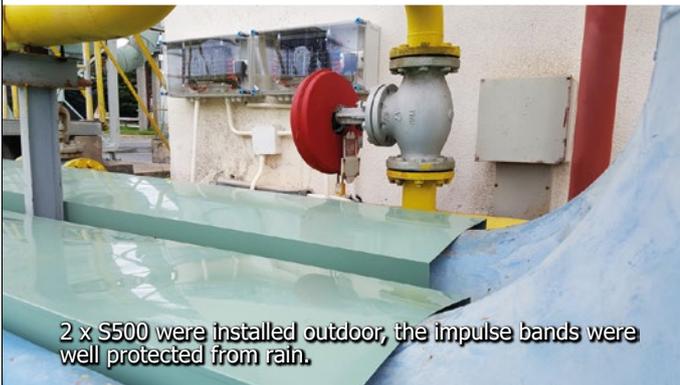
2 x S500 were installed outdoor, the impulse bands were well protected from rain.

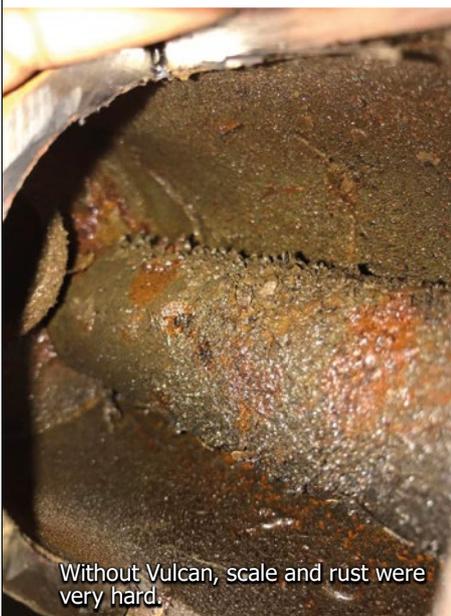
Without Vulcan, scale and rust were very hard.

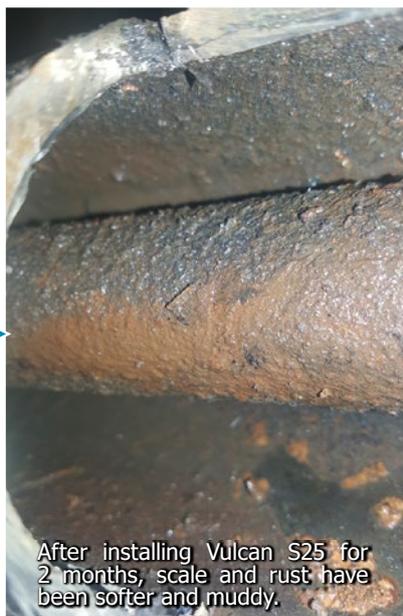
After installing Vulcan S25 for 2 months, scale and rust have been softer and muddy.

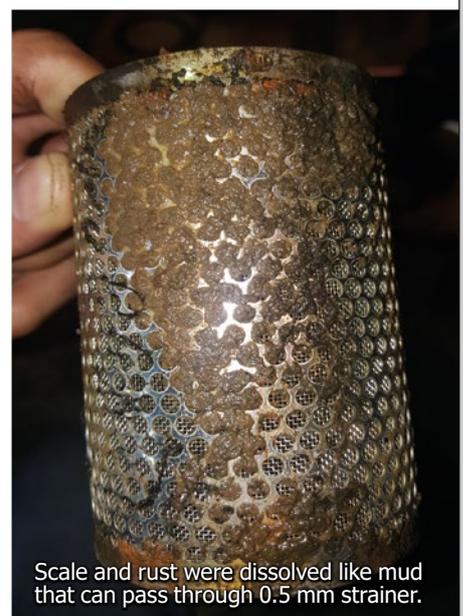
Scale and rust were dissolved like mud that can pass through 0.5 mm strainer.
