The Electronic Anti-Scale System For Hospitality Applications

Vulcan – The alternative to water softeners

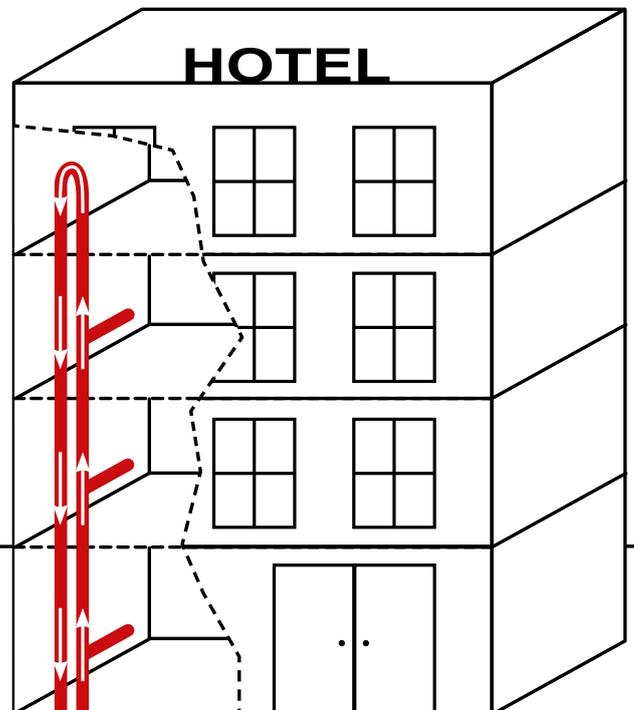
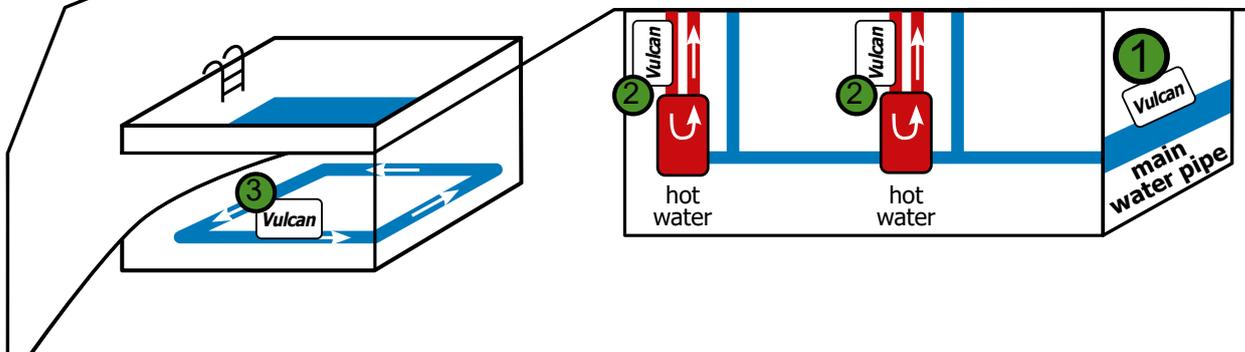
Below is an example of a typical Vulcan installation in a hotel.

Installation areas are often the main building cold water supply (1), one or several hot water circulations (2) for the higher floor levels, in pool & spa operations (3), in restaurant sections etc.

Each water circulation needs an own Vulcan.

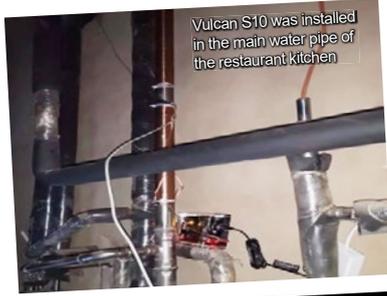
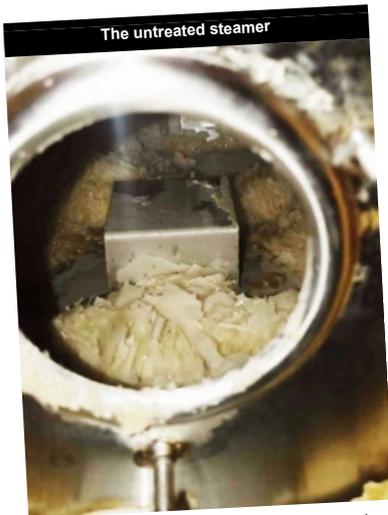
The scale was in flakes and could not be drained out of the steamer's drain hole. To test the effectiveness of the Vulcan system, no cleaning process was carried out before installing the Vulcan S10.

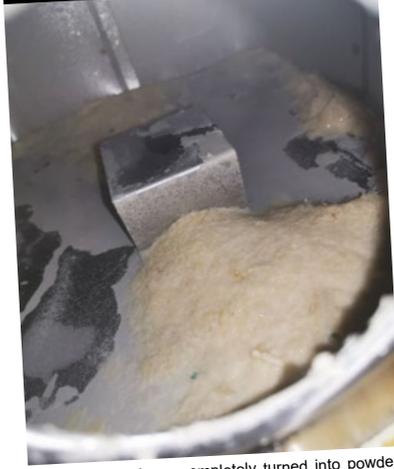
The steamer after using Vulcan S10 for 2 months

The scale has been completely turned into powder, so there is no need to open it for cleaning, just by operating the regular drainage function, it can keep the hot water tank clean and free of scale. Due to the good results, the cooperation will also be carried out in the hotel's hot water supply system and central air conditioning system.

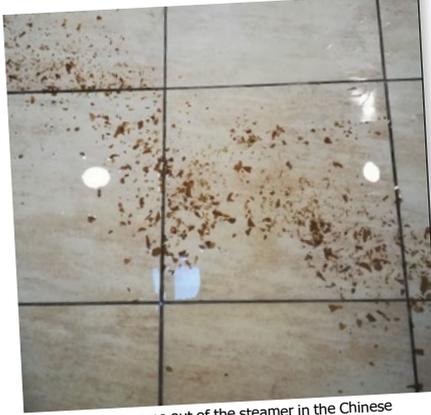
The scale scrap came out of the steamer in the Chinese kitchen.

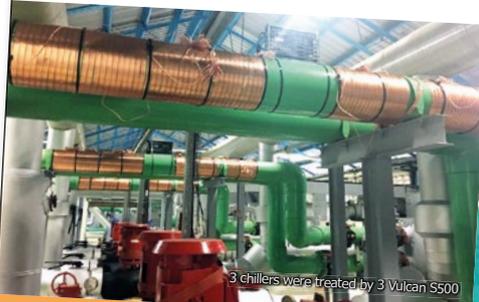
3 chillers were treated by 3 Vulcan S500

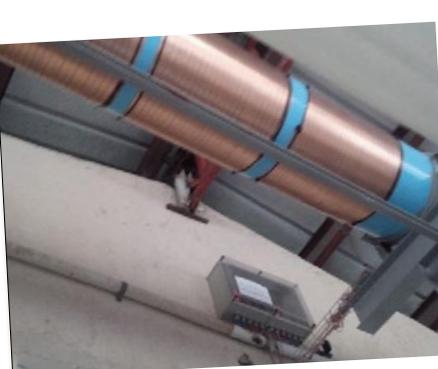
Vulcan S500 protective casing

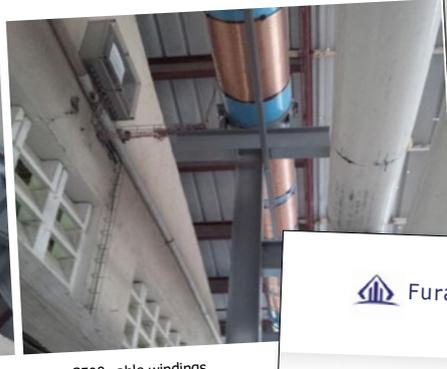
Vulcan S500 cable windings

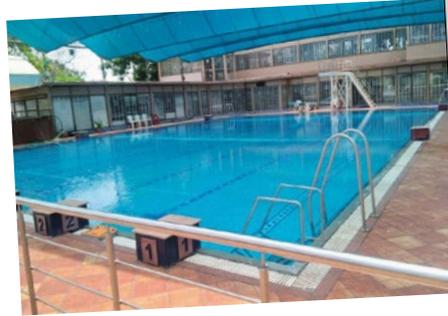
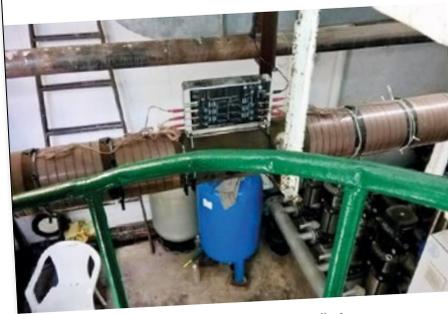
Two Vulcan S100 were installed.

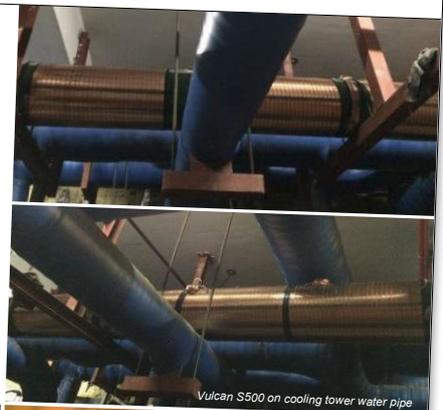
Vulcan S500 on cooling tower water pipe

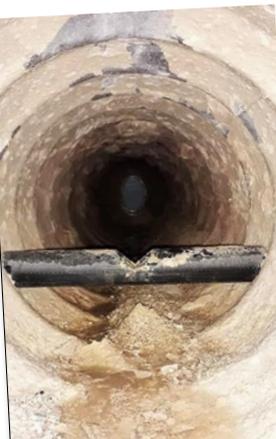
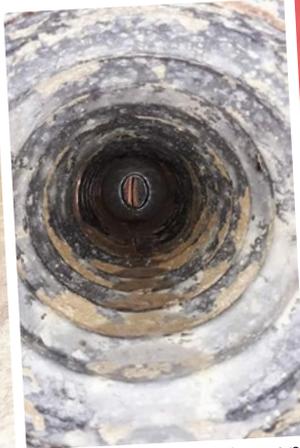
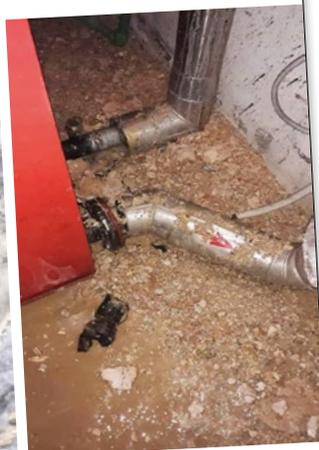
After Vulcan S25 had been installed for **6 months**, the boiler was opened: scale had been softer and left out.

The scale deposits were easily removed with a water gun.

The scale deposits were drained out of the boiler with ZERO chemical.

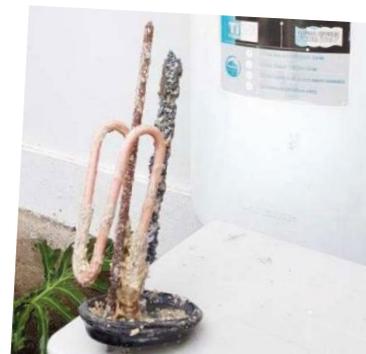
The little remaining scale is soft and easily flushed out since installation of the Vulcan Anti-Scale System.

One of the water heaters at a Sea View Bungalow (photo) was opened for inspection and showed much dislodged scale particles at the bottom of the tank, with some easily removed soft scale still present on the element only. This water heater unit had not been scheduled for random inspection since installation of the Vulcan unit at the Resort.

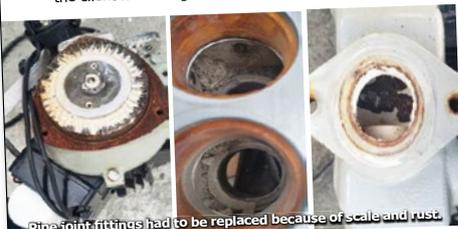
Pipe joint fittings had to be replaced because of scale and rust.

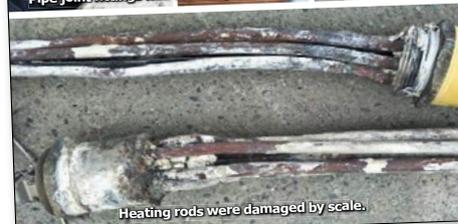
Heating rods were damaged by scale.

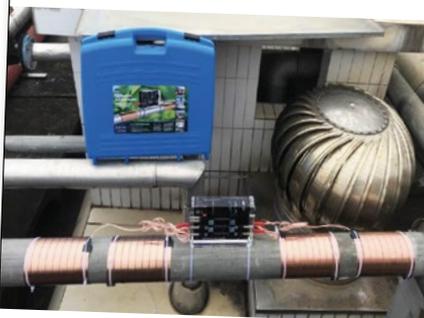
Vulcan S25 was installed on the main water pipe of the guest room Building B.

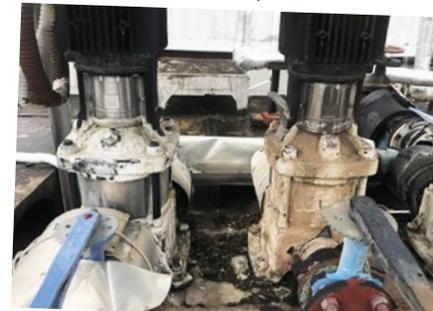
On the left is the pipe (without scale) after Vulcan S25 was installed for 2 months; on the right is the pipe without any water treatment.

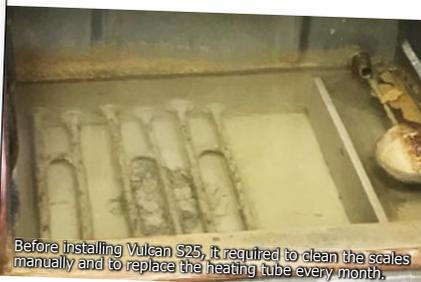
Before installing Vulcan S25, it required to clean the scales manually and to replace the heating tube every month.

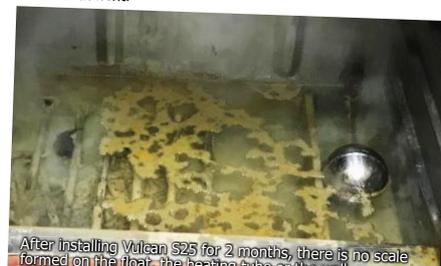
After installing Vulcan S25 for 2 months, there is no scale formed on the float, the heating tube or the wall.
